NASA TECHNICAL MEMORANDUM

NASA TM SX-1076

RESPONSE OF A WB-47E AIRPLANE TO RUNWAY ROUGHNESS AT EIELSON AFB, ALASKA, SEPTEMBER 1964

by Garland J. Morris and Albert W. Hall
Langley Research Center
Langley Station, Hampton, Va.

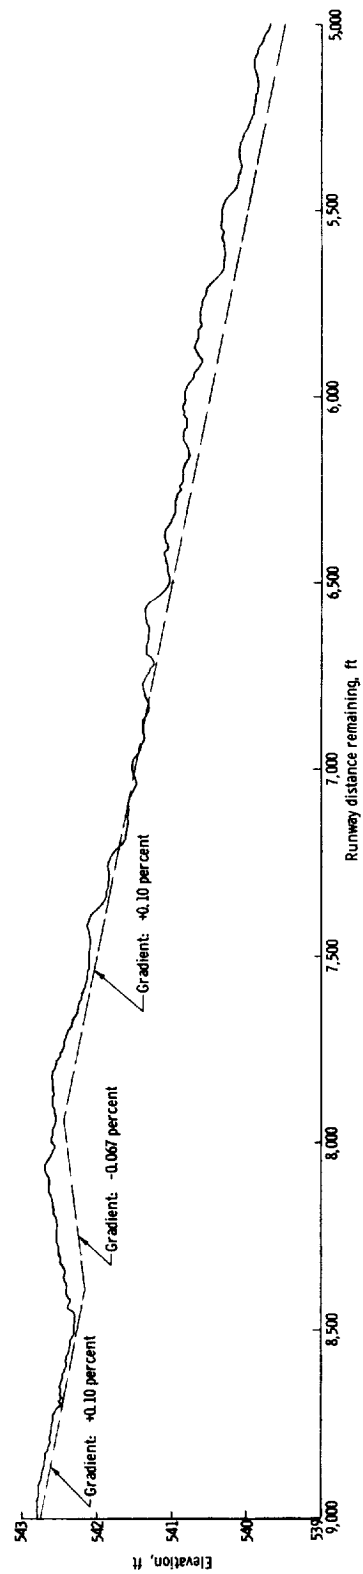
Figure 3.- Elevation profile for center line of runway 31, Eielson AFB, Alaska (U.S. Air Force survey).

The test runway, identified as runway 31 in one direction and as 13 in the other, is 14,500 feet long. A detailed profile of the entire runway is not available; however, the profile of a 4000-foot portion of runway 31 between 9000 feet and 5000 feet is shown in figure 3. Throughout this paper the runway locations will be given in terms of the 1000-foot markers (distance remaining) along runway 31. This profile is based on an Air Force survey made along the center line of the runway at 10-foot intervals during May 1964. The gradients to which the runway was constructed in 1949 are also shown.

A large long-wavelength bump in the runway is evident where two positive gradients of about 0.10 percent are joined by a negative gradient of about 0.07 percent at approximately the 8500-foot and 8000-foot stations. This portion of the runway has been the subject of the majority of the roughness complaints; especially those stemming from difficulties encountered in maintaining control of the airplane. Shorter wavelength irregularities such as those at the 8500-, 8100- and 7800-foot locations within this region are the apparent source of the objectionable responses. Examination of the profile beyond this location indicates the presence of a number of surface irregularities, such as those at 7400, 7250, and 6600 feet, which also might be expected to result in substantial airplane response.

In view of the foregoing discussion, it is thought that two aspects of the roughness should be considered in determining the extent of repairs which may be deemed necessary to the runway. First, in order to reduce the pilot-compartment accelerations, repairs to a number of sections of the runway apparently would be required as indicated by the results in figure 6. Second, the pitching oscillations (which appear to be the cause for concern) could apparently be alleviated significantly by eliminating the bumps or irregularities between the 8500- and 7200-foot stations.

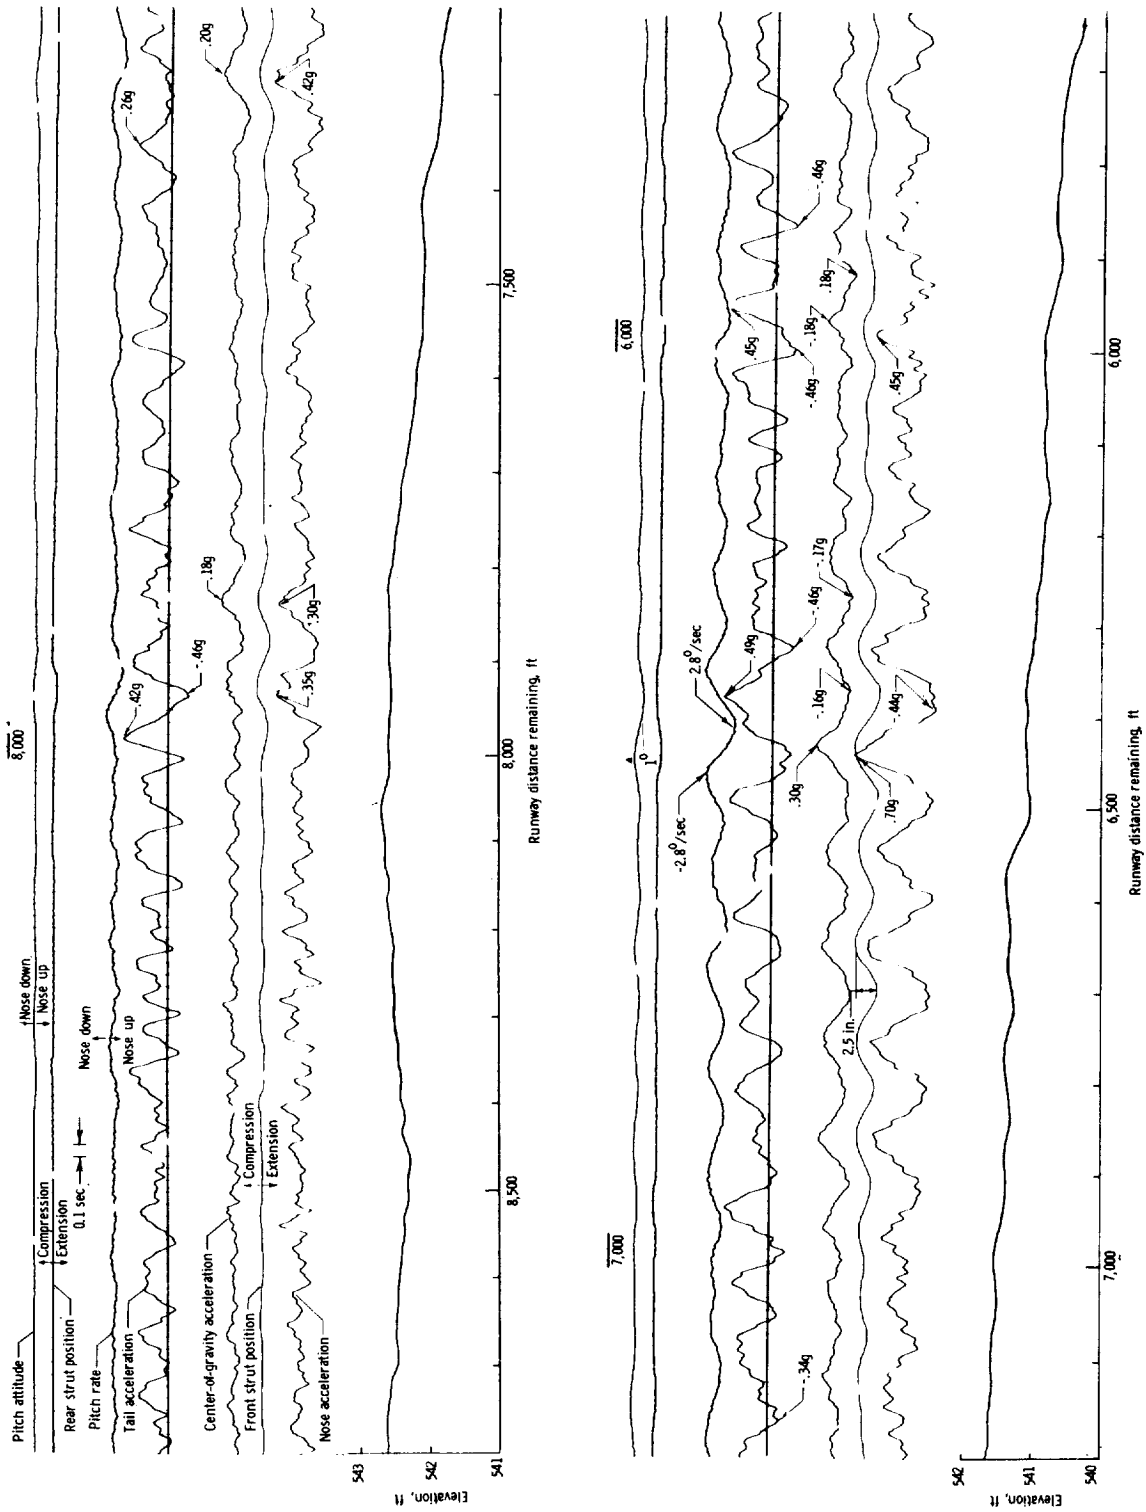
Figure 4.- Elevation variation of runway 31 and resulting airplane response at 75 knots taxiing speed.

Sample records of the responses of the airplane are shown in figures 4 and 5. These results were obtained during runs 4 and 8 (table I) for which taxiing speeds were 75 and 100 knots, respectively. The runway profile shown below the records indicates the approximate runway stations at which the responses were measured. The responses shown in the figures are airplane pitch attitude, pitch rate, and normal acceleration at the nose, center of gravity, and tail, as well as front- and rear-landing-gear strut positions. The magnitudes of several of the peak responses are indicated. The values of acceleration are in terms of incremental g units above (+) and below (-) the static 1.0g value. Airplane pitch attitude shown in figures 4 and 5 is referred to the static attitude (wing angle of attack approximately 8°) at the beginning of each run.

Examination of figures 4 and 5 shows several points of interest relative to the airplane responses to the runway roughness. It is evident that the roughness caused substantial acceleration response continually during the traverses of the runway and that certain locations along the runway are more conducive to high responses than are other locations. For example, figure 4 shows that, for the 75-knot taxiing speeds, the roughness near the 8000-foot location resulted in pilot-compartment accelerations as high as 0.35g. Likewise, the roughness between 7000 feet and 6300 feet caused sustained pitching motions and pilot compartment accelerations as high as 0.7g and -0.44g. The responses cited were

Several major frequency response modes are evident in figures 4 and 5 with frequencies ranging from around 0.8 cps to 4.0 cps. The wavelengths of runway irregularities which have the greatest effect on airplane response at these frequencies depend on the taxiing speed. For example, at a taxiing speed of 150 knots, runway irregularities having wavelengths of 316 feet and 63 feet would be expected to cause large response at 0.8 cps and 4.0 cps, respectively, whereas at 75 knots wavelengths of 158 feet and 32 feet would likely cause the most response at these frequencies. In addition to the dependence of the airplane response over a particular area on taxiing speed, the response on one area can be dependent on aircraft motions that were started by the previous area. The effect of speed is illustrated in figures 4 and 5 where a considerable response is shown near the 8000-foot station at a speed of 75 knots, but very little response to this area is shown at 100 knots. In each case the greatest response is caused by the rough area near the 6500-foot station.

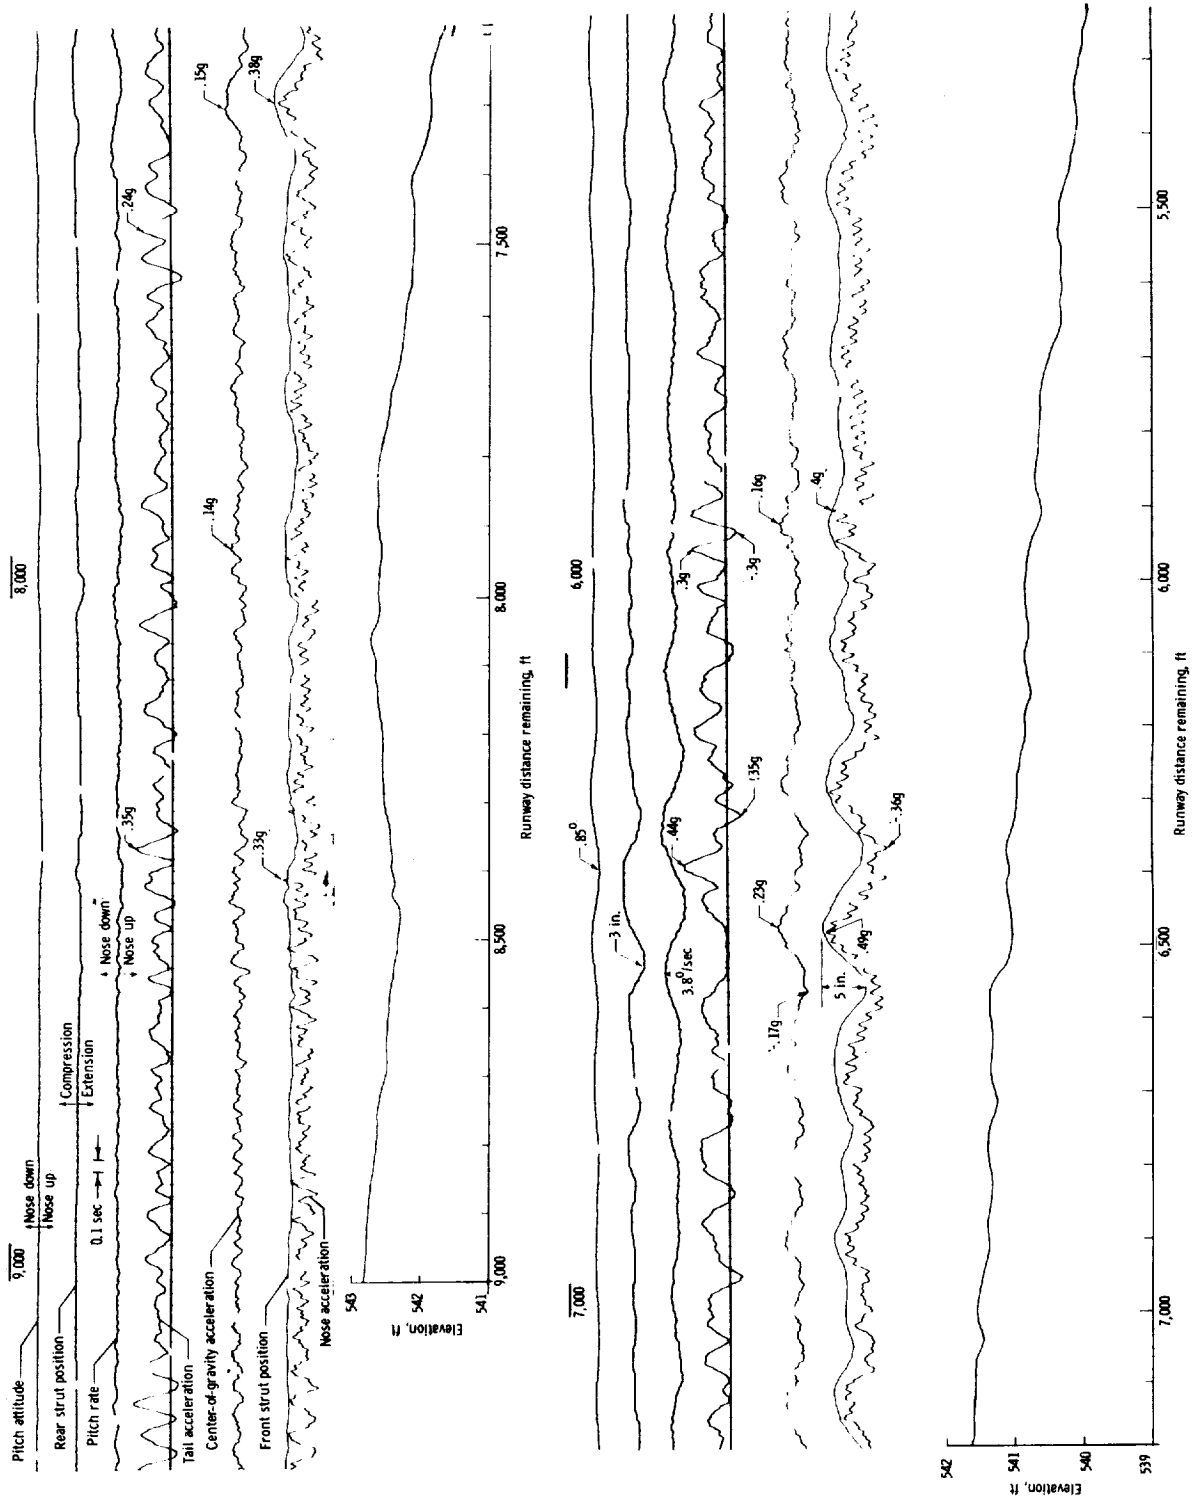
Figure 5.- Elevation variation of runway 31 and resulting airplane response at 100 knots taxiing speed.

at a frequency of approximately 1.25 cps. Responses at this frequency and speed would be excited by runway irregularities having wavelengths of approximately 100 feet.

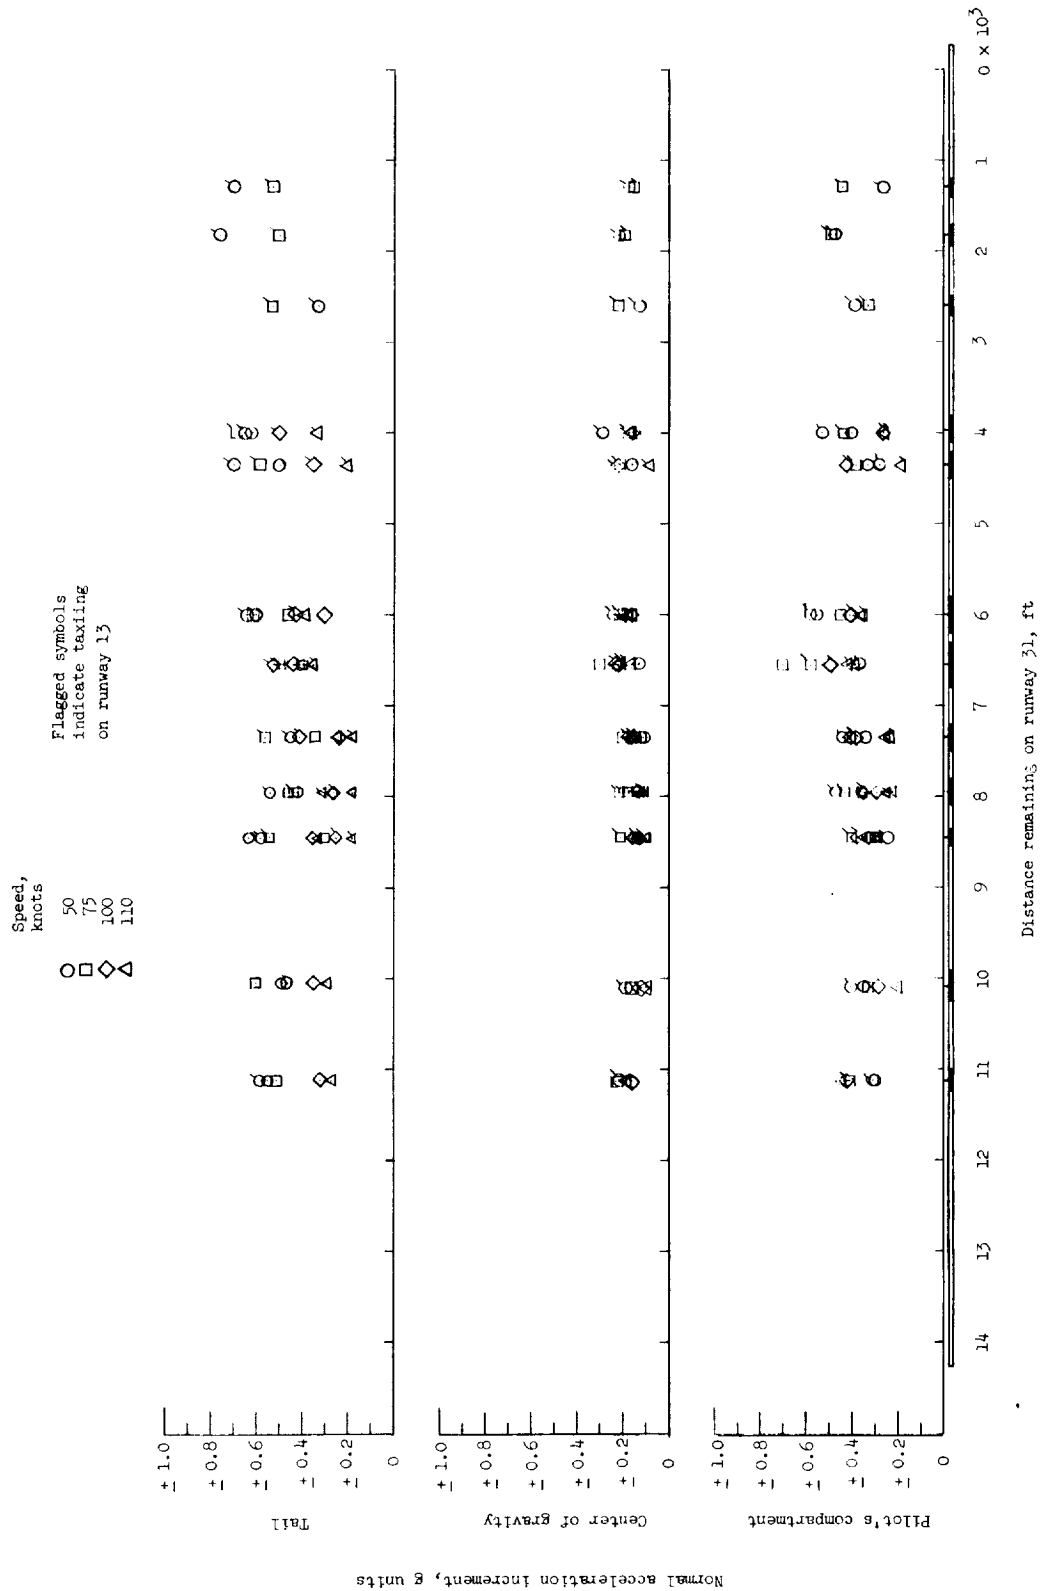
Figure 6.- Maximum acceleration response of airplane measured during taxiing on various sections of runway 31.

The peak values of the accelerations at the pilot's compartment (nose), the center of gravity, and the tail (table I) are plotted in figure 6 at the midpoint of each of the 12 sections of runway judged to have caused the major responses. It is noted that the acceleration of the pilot's compartment exceeded 0.4g in each of the areas during traverse at one or more of the four taxi speeds. Based on the acceleration of the pilot's compartment, the roughest area is between 6700 feet and 6300 feet.

Comparison of the results in figure 6 for taxiing in the two directions on the runway does not show a significant effect of taxi direction on the responses. In addition, results of two taxi runs on either side of the center line were not significantly different from those shown in figure 6. Thus, it is not believed that the roughness can be alleviated by operating on either side of the center line.

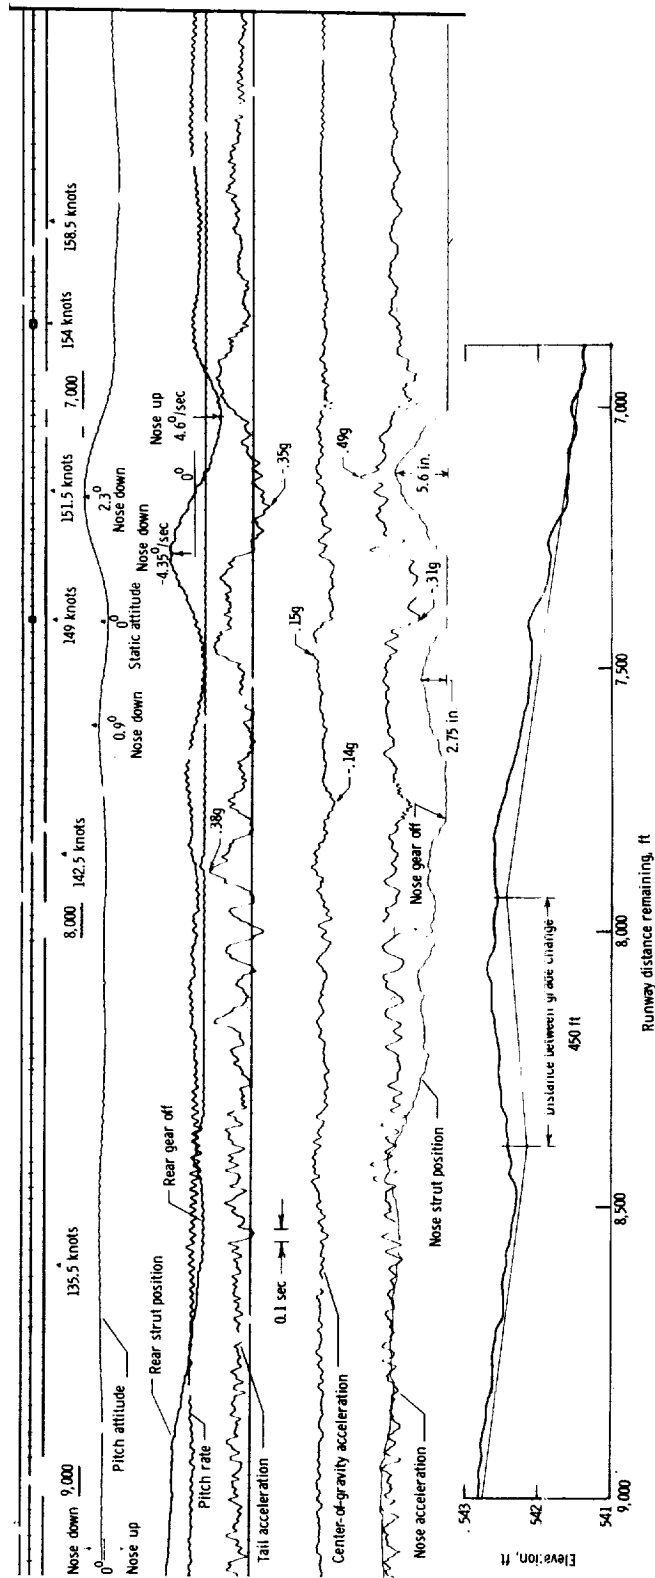
(a) First take-off. (Rear wheels lift off first.)

First take-off.- Examination of the airplane-response time histories for the first take-off (fig. 7(a)) shows that the rear wheels lifted off first at about the 8500-foot runway position while the airspeed was approximately 135 knots. The rear wheels remained off the runway for the remainder of the take-off except for momentary contact at about 8400 feet and 7800 feet.

During this take-off (fig. 7(a)), the nose gear first left the runway at the break in the profile at about 7800 feet. Between this location and the final lift-off at 7000 feet, a pitch oscillation existed such that the nose wheel was alternately in and out of contact with the runway. Thus, both gears were off the ground for about 0.5 second near 7800 feet with an airspeed of approximately 143 knots and again near 7400 feet with an airspeed of 149 knots. The airspeed at final lift-off was 153 knots, which is in good agreement with the handbook value of 152 knots.

The acceleration response in the pilot's compartment (fig. 7(a)) was less than $\pm 0.25g$ except during the last 500 feet of travel where maximum accelerations of $-0.31g$ and $0.49g$ were experienced. These peak accelerations were associated with the pitching motions of the airplane and the attendant alternating contact of the nose gear with the runway. The pitch attitude response during the take-off was in the nose-down direction and a maximum value of 2.3° less than the normal ground attitude was experienced during the pitch oscillation prior to lift-off. Control motions were not recorded during these tests; therefore, it is not known whether there were inadvertent or deliberate elevator control motions to either increase or damp this oscillation.

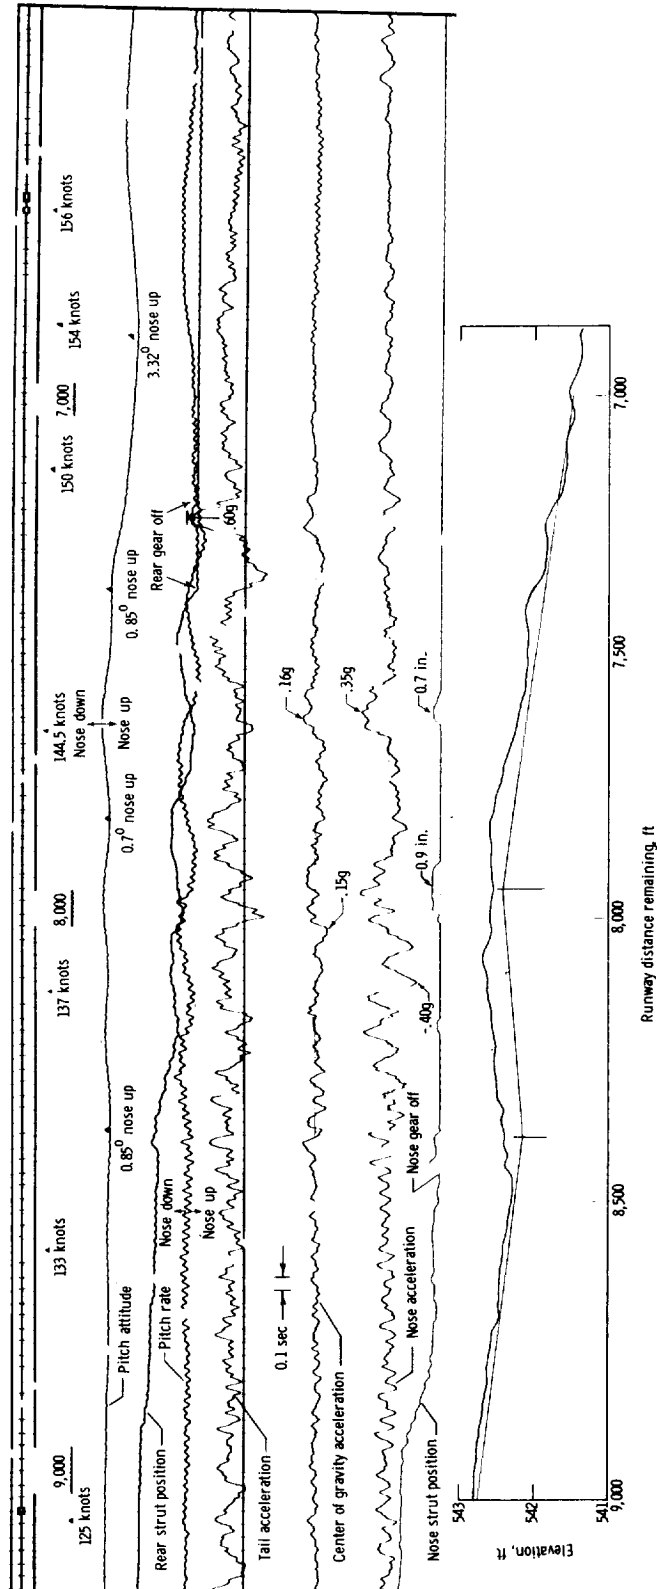
(b) Second take-off. (Front wheels lift off first.)

Second take-off.- Examination of the airplane response time histories for the second take-off (fig. 7(b)) shows that the front wheels lifted off first at about the 8500-foot runway position at an airspeed of approximately 134 knots. The front wheels were off the runway for the remaining take-off distance except for momentary contact at four locations (near 8400, 8200, 8000, and 7600 feet) due to a slight pitching motion of the airplane.

The bump at the 7400-foot location caused the airplane to become completely airborne at a speed and attitude which were too low to maintain flight so that the rear wheels hit the next bump at 7300 feet. At this point, the airspeed was about 148 knots and the attitude was about 2° above normal. Although the lift-off speed was 4 knots below handbook lift-off speed, the airplane was able to maintain flight from this point on.

The acceleration response in the pilot's compartment was less than $\pm 0.25g$ except during the final stages of the take-off where maximum accelerations of $-0.40g$ and $0.35g$ were experienced. Thus, the maximum acceleration response

during the second take-off was not significantly different from that experienced during the first take-off (-0.31g and 0.49g).
